**PRELIMINARY ASSESSMENT/
VISUAL SITE INSPECTION**

**PIERCE AND STEVENS CHEMICAL CORP.
CAROL STREAM, ILLINOIS
ILD 055 434 443**

FINAL REPORT

Work Assignment No.	:	R05032
EPA Region	:	5
Site No.	:	ILD 055 434 443
Date Prepared	:	September 7, 1993
Contract No.	:	68-W9-0006
PRC No.	:	R05032-IL31
Prepared By	:	Dynamac Corporation (Russ Crittenden)
Telephone No.	:	(312) 466-0222
Contractor Project Manager	:	Shin Ahn
Telephone No.	:	(312) 856-8700
EPA Work Assignment Manager	:	Kevin Pierard
Telephone No.	:	(312) 886-4448

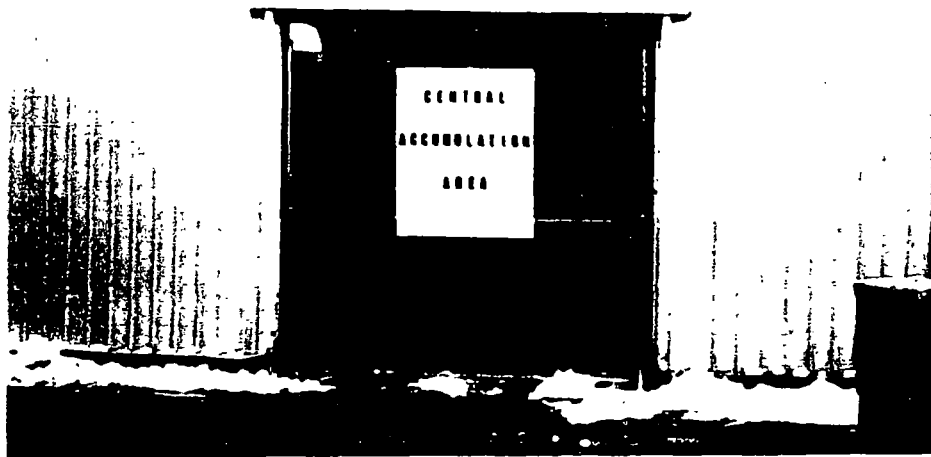
The Central Accumulation Area is located within a 25-foot by 50-foot shed outside the east side of the plant (See Figure 2). This unit is used for the accumulation of up to three hundred 55-gallon steel drums of hazardous wastes and material to be reused. The unit is also used for the storage of nonhazardous wastes in 55-gallon fiber barrels and plastic pails (See Photo Nos. 1, 2, and 3). The unit is constructed of aluminum and cinder block walls, and a concrete floor. The north side of the unit has no wall, but is fenced. The entrance to the Central Accumulation Area is a locked gate (See Photo No. 1).

Photo No.: 1
Orientation: East
Description: Locked gate to Central Accumulation Area.

Location: SWMU 1
Date: January 27, 1992

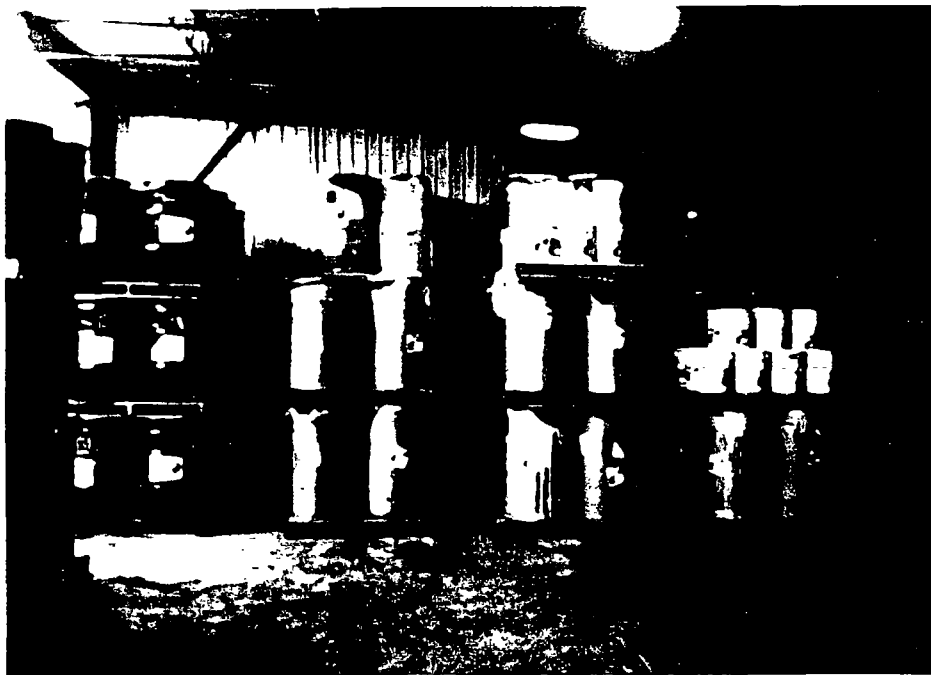
Photo No.: 3 **Location:** SWMU 1
Orientation: East **Date:** January 27, 1992
Description: Nonhazardous waste coagulant in fiber barrels on right. Rework material in steel drums on left.

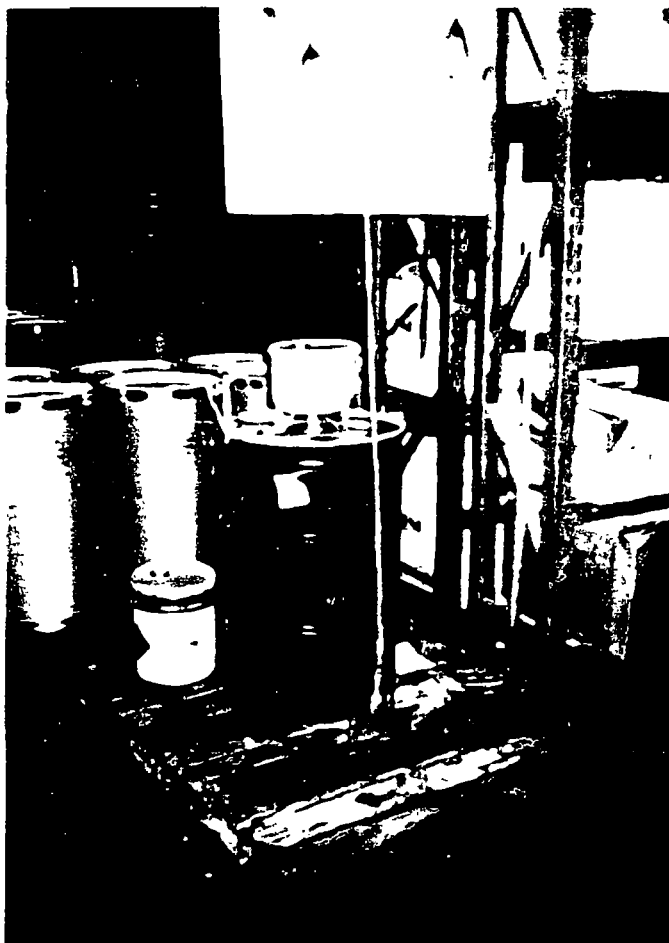
Photo No. : 5
 Location : SWMU 2
 Orientation : Southeast
 Date : January 27, 1992
 Description : Waste Toluene
 Mixture Satellite Accumulation Drum
 located on first floor of manufacturing
 area.

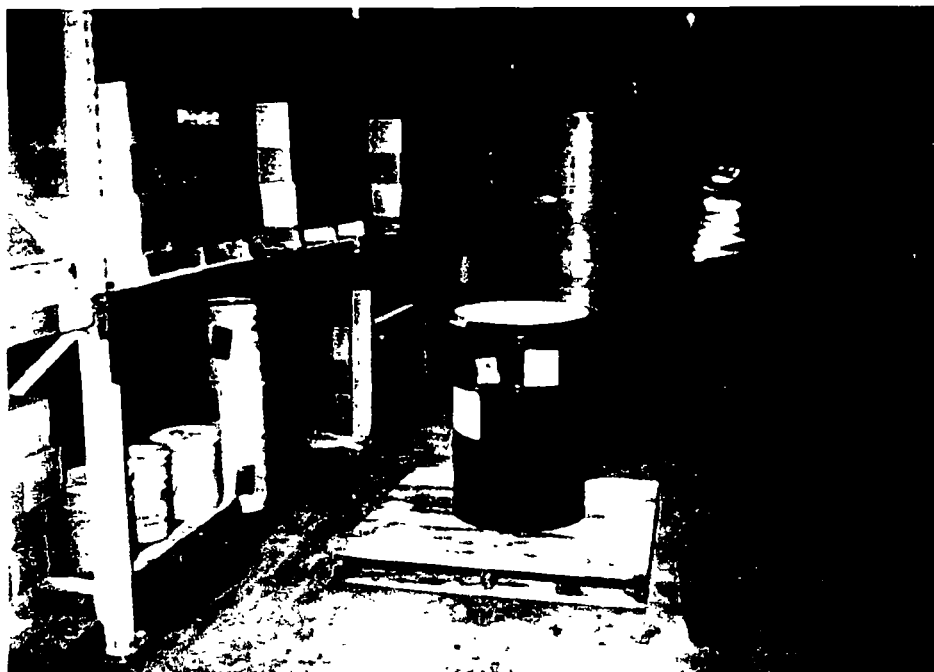
Observations: Dynamac observed that this unit was well maintained. The drums and funnel were closed and marked. Dynamac notes that one full drum of waste toluene mixture had been moved from the Satellite Accumulation Area, but had not been taken all the way to the Central Accumulation Area (SWMU 1). This drum was on a pallet in the finished goods area of the plant (See Photo No. 6). PSC representatives stated the employee authorized to put the drums in the Central Accumulation Area was not present, and the drum would be moved on his return.

Photo No.: 6
 Orientation: North
 Description: Waste toluene mixture in labeled drum placed in finished goods warehouse during transit to
 Central Accumulation Area (SWMU 1).

Location: Finished Goods
 Date: January 27, 1992

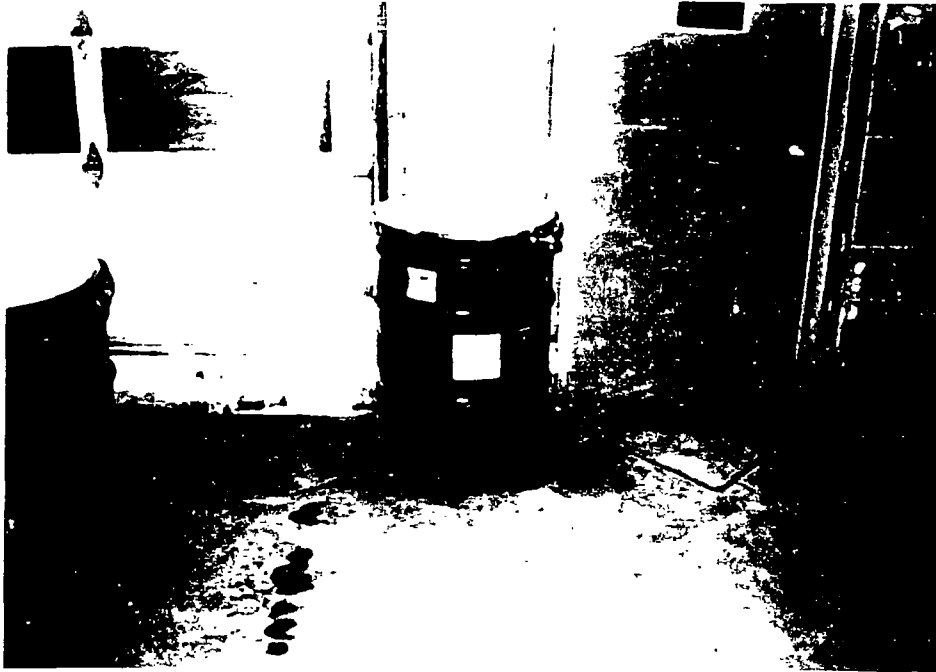
Photo No.: 7

Observations: Dynamac observed that this unit was well maintained and there was no evidence of spillage.

Orientation: East

Location: SWMU 3

Date: January 27, 1992

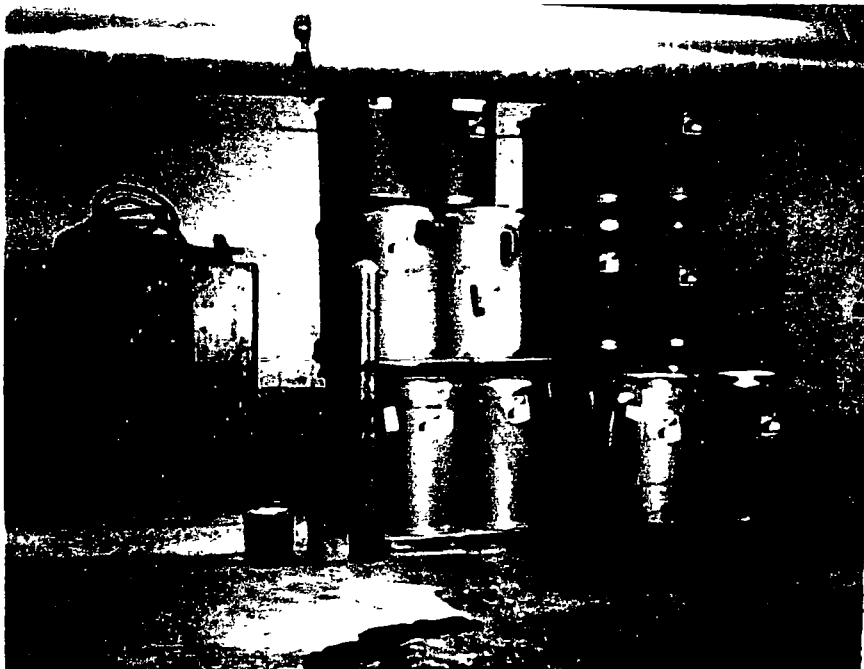
Photo No.: 9
Orientation: North
Description: East Dock. Fiber barrels of nonhazardous waste coagulant.

Location: SWMU 4
Date: January 27, 1992

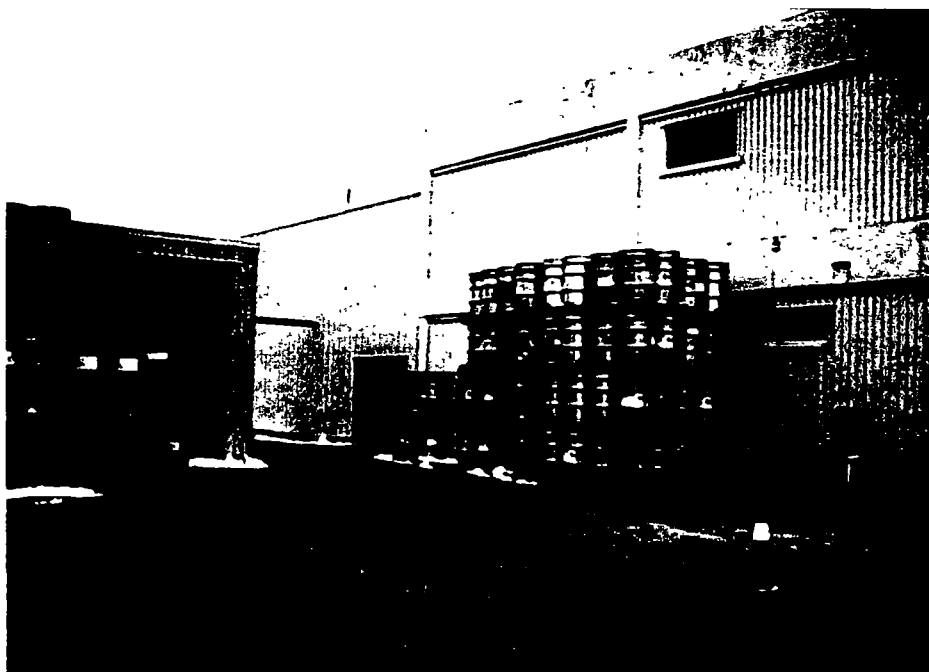
Observations: The concrete pad was clean and there was no evidence of spills. Dynamac observed approximately 450 empty 55-gallon drums.

PSC maintains three steel 7,500-gallon molten wax USTs under the concrete pad on the east side of the plant (See Figure 2). The USTs are located immediately north of the Empty Drum Storage Area (SWMU 5) (See Photo No. 10). These USTs were installed in 1972, and have not been subjected to tightness testing. There has been no evidence of release from these USTs, but due to the fact that they have not been leak-tested, the possibility of future leakage cannot be eliminated.

Photo No.: 10
Orientation: Southwest
Description: Empty Drum Storage Area. Approximately 150 empty drums for return to original vendor. Concrete pad in foreground overlies the East Pad USTs (AOC 3).

Location: SWMU 5
Date: January 27, 1992

Recommendations: Tightness testing should be conducted on these USTs, and follow up actions, as appropriate, should be implemented if any of the USTs fail the test.

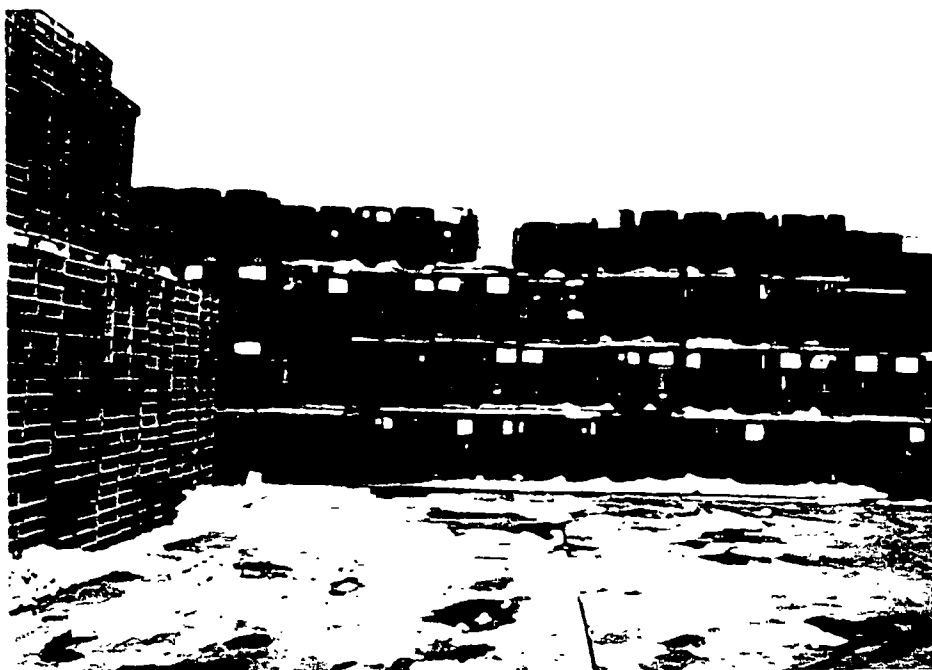
Photo No.: 11

Location: SWMU 5

Date: January 27, 1992

Description: Empty Drum Storage Area. Empty drums for shipment to drum reconditioner. Central Accumulation Area (SWMU 1) shed located is immediately behind empty drums.
